dryvitCARE™ EIFS Repair Procedures DS498

Index of Documents

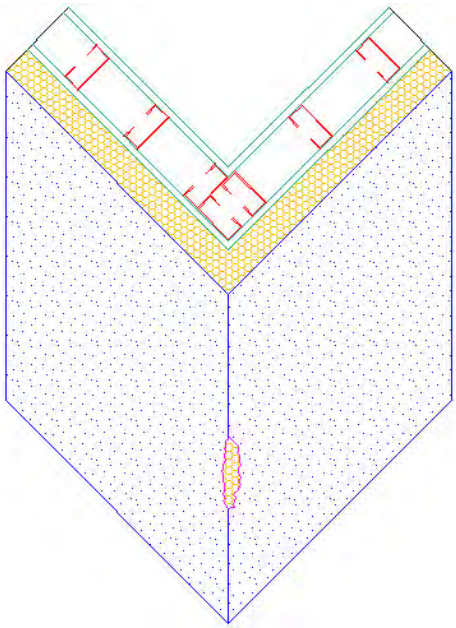
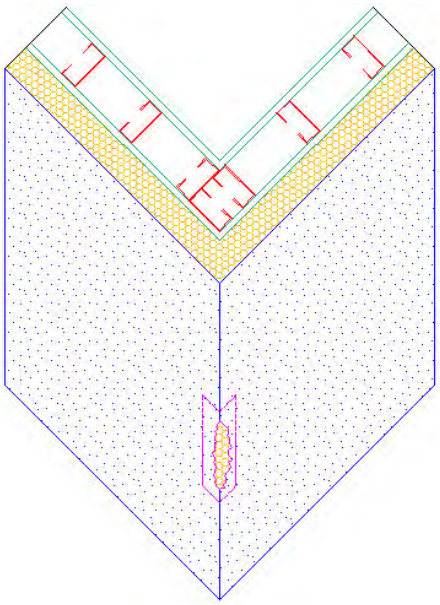
EIFS Repair –Corner Damage

Corner damage may be caused by impact from objects such as carts, cars or vandalism. Repair involves removing and replacement of materials in the affected area.

2. Examine the piece removed to determine if there is any damaged to the sheathing.
3. If any damage to the substrate is present, repair prior to EIFS application.

1. Ensure that the existing finish coat is clean, dry and firmly bonded to the base coat.
2. Apply NCB™; in conjunction with reinforcing mesh, onto newly installed insulation board and overlap onto existing finish coat a minimum of 64 mm (2 1/2"). **Only a noncementitious base coat can be used with this procedure**. Allow patch locations to completely dry.
3. NCB is not recommended for applications on surfaces that will receive sealant. Any of Dryvit's cementitious base coats may be used in those locations.
4. Apply a tight coat of Freestyle® finish or NCB over existing texture and blend in patch locations with skim coat. The wall will need to be skimmed and refinished to a natural break. Allow to fully dry.
5. Apply new finish coat and texture to match existing.

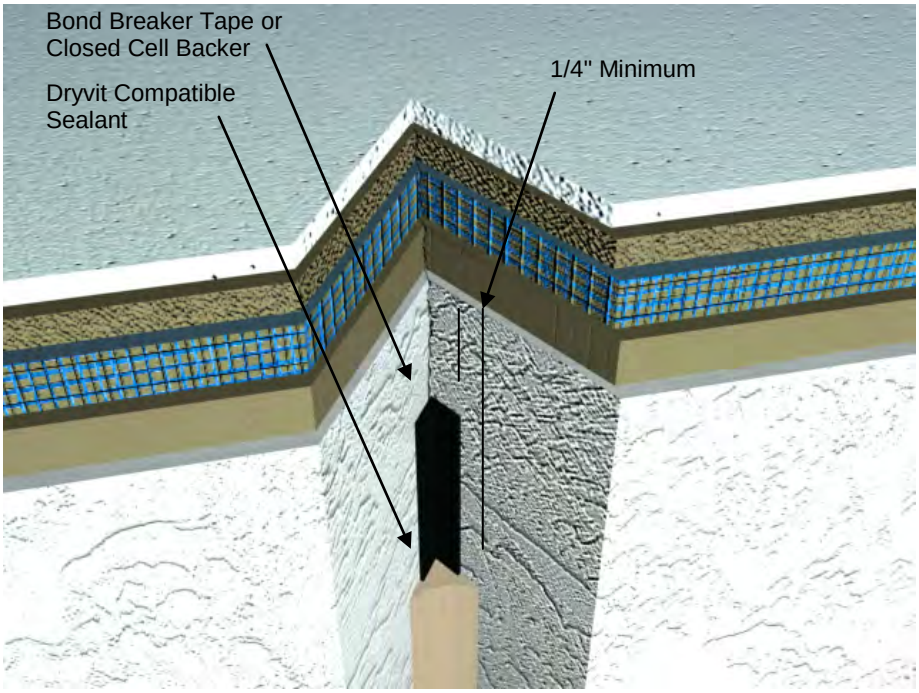
EIFS Repair –Cracks in Aesthetic Reveals DC005

Cracks at the base of aesthetic reveals can sometimes occur. Some of the possible reasons may include substrate movement, excessive build up of base coat or accidental cutting of the mesh during installation. Generally, these cracks can be repaired easily by adding sealant along the base of the groove. This provides a weather seal as well as stress relief at those locations.

1. Clean the area to remove all dust, dirt, algae or other surface contamination as well as any loose material. A general all-purpose cleaner is usually adequate. For specific recommendations refer to DryvitCARE published cleaning procedures (DC#001) for EIFS surfaces.
2. Install a small closed cell backer rod or bond breaker tape along the base of the groove, to provide the proper sealant joint geometry and to avoid 3-sided adhesion. Small intermittent dabs of sealant may be used to maintain position until the sealant is applied.
3. Apply the specified sealant primer to each surface and allow it to dry.
4. Install and properly tool the sealant in accordance with the sealant manufacturer's instructions. A minimum 6.4 mm (1/4") contact area to the EIFS surface along each side of the groove is recommended.
5. Protect the joint from weather until sealant has achieved adequate cure.

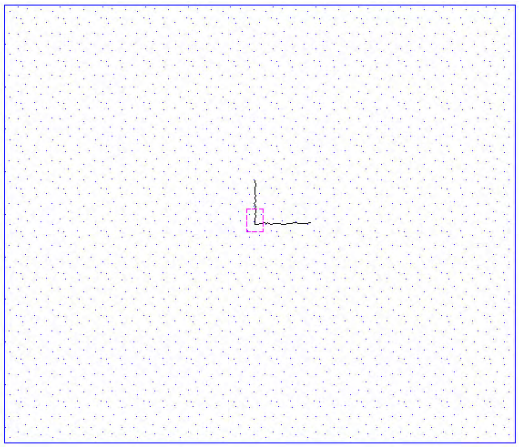
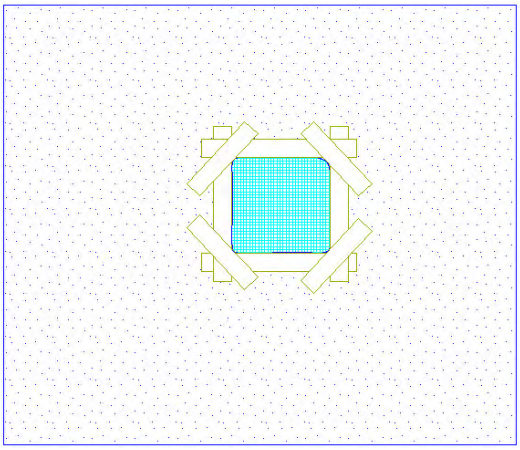
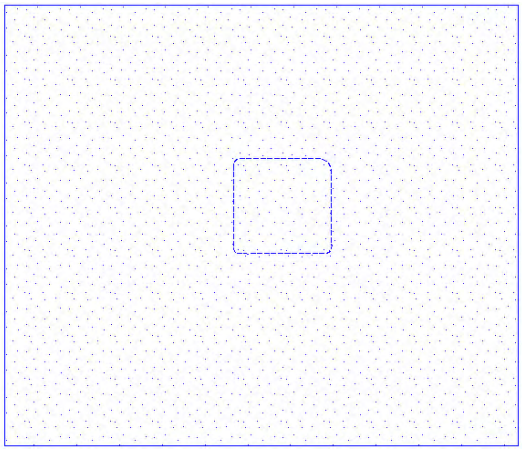
Cracks can sometimes occur as a result of structural movement, water penetration or improper application. Repair involves removal and replacement of materials in the affected area. Before proceeding, the exact cause of cracks should be determined.

1. Using a sharp utility knife, hand or circular skill saw with a carborundum blade, cut an approximate 76 mm x 76 mm (3" x 3") square into EIFS at crack location, down to the substrate. With a margin trowel or similar tool, carefully remove the section in one piece.

2. Verify that the substrate is undamaged and structurally sound.
3. Cut out minimum 76 mm (3") on each side of crack down to substrate.
4. Grind off finish minimum 76 mm (3") on each side of the cut out section to expose the existing base coat layer. **Do not cut into reinforcing mesh with grinder**. The edges of the finish should be sharp, clean and non-tapered from the finish down to the base coat layer.

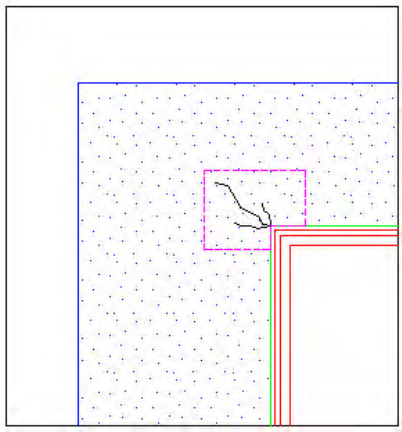
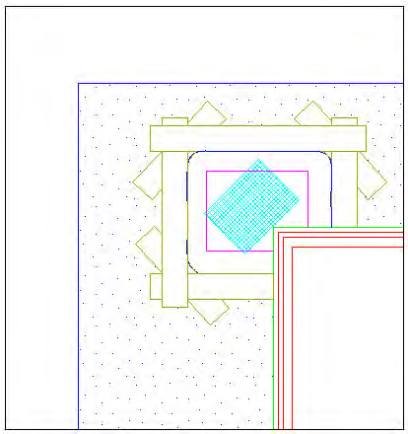
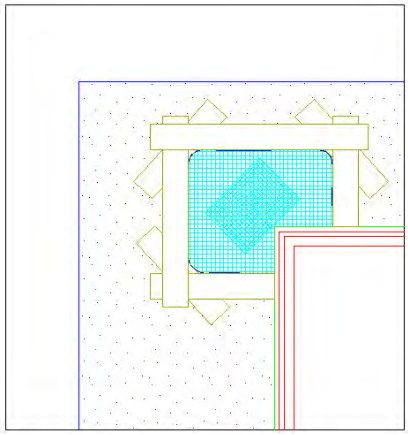
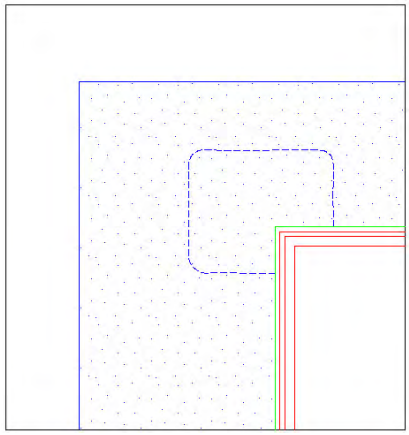
EIFS Repair –Cracks at Corners of Doors, Windows, Air Conditioners, Etc. DC007

Cracks can sometimes occur as a result of structural movement, water penetration or improper application. Repair involves removal and replacement of materials in the affected area. Before proceeding, the exact cause of the cracks should be determined.

1. Using a sharp utility knife, hand or circular saw with a carborundum blade, cut into EIFS down to substrate approximately 152 mm (6") along jamb and sill or jamb and head depending on crack location. These cuts should be long enough to totally remove the cracked area. Make vertical and horizontal cuts so that a square piece of EPS is removed.

1. Ensure that the existing finish coat is clean, dry and firmly bonded to the base coat.
2. Apply NCB™; in conjunction with reinforcing mesh, onto newly installed insulation board and overlap onto existing finish coat a minimum of 64 mm (2 1/2"). **Only a non-cementitious base coat can be used with this procedure**. Allow patch locations to completely dry.
3. NCB is not recommended for applications on surfaces that will receive sealant. Any of Dryvit's cementitious base coats may be used in those locations.
4. Apply a tight coat of Freestyle finish or NCB over existing finish texture and blend in patch locations with skim coat. The wall will need to be skimmed and refinished to a natural break. Allow to fully dry.
5. Apply new finish coat and texture to match existing.

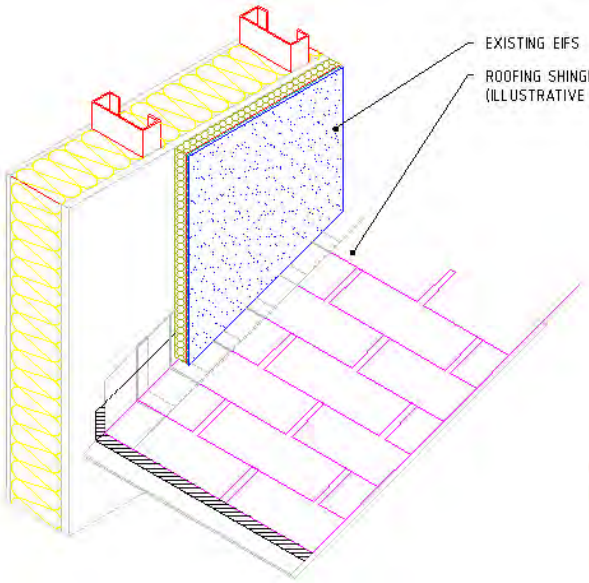
Figure 1

This procedure describes the method for obtaining the required minimum 51 mm (2") clearance of the EIFS termination to roof assembly, when it has been installed tight to the shingles and not properly back wrapped. Dryvit recommends that the system be held up from the shingles by a minimum of 51 mm (2") to allow repairs to the roof without damage occurring to the system (See Figure 1).
